Report #295

Red River Coal Company Benthic Macroinvertebrate Survey Fall 2014 SFP-1

Biological Monitoring, Inc. 1800 Kraft Drive, Suite 104 Blacksburg, VA 24060 Phone: 540-953-2821 Fax: 540-951-1481

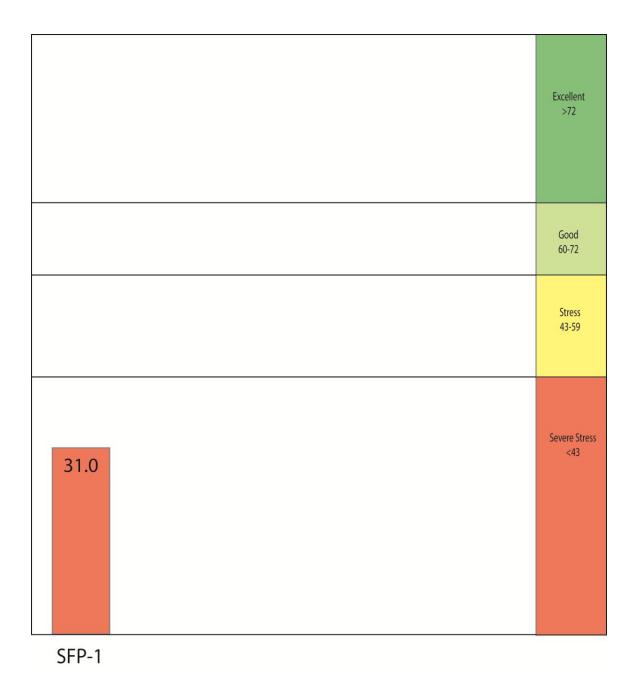
Figure 3. VASCI Scoring Summary

Table 6 presents a summary of the VASCI scoring. Raw data are presented in Appendix B. Each metric score represents a percentage of the statewide reference condition. The VASCI score calculated for SFP-1 was 31.04.

Figure 3 is a graphical representation of the VASCI score(s) along with the Aquatic Life Use Tiers. It should be noted that four tiers exist in the VASCI, whereas, a score of 60 or higher is considered "unimpaired" and a score of < 60 is considered "impaired".

The VASCI score calculated was 31.04 for station SFP-1. This score falls into the "Severe Stress" Aquatic Life Use tier.

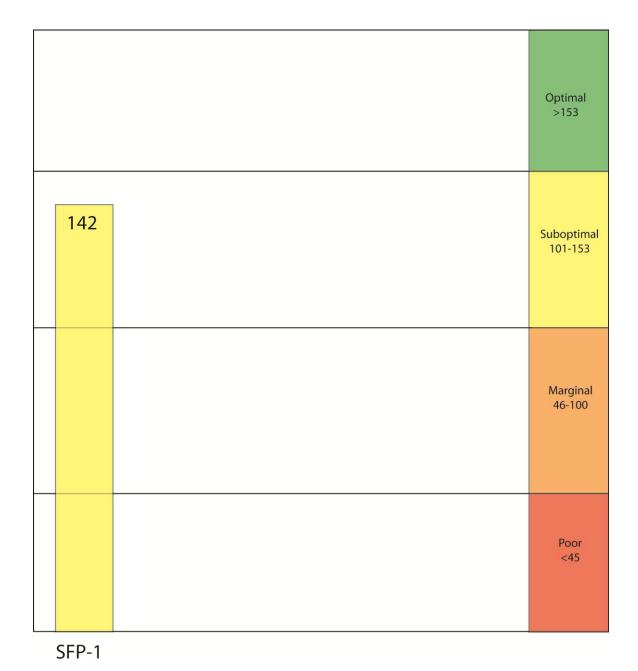
Figure 4. Habitat Scoring Sumary

Table 7 presents a summary of the habitat assessment score for the monitoring stations. Raw data are presented in Appendix B. The habitat assessment score was 142 for SFP-1 falling into the "Suboptimal" category of habitat.

Figure 4 is a visual representation of the habitat score(s) obtained for this permit along with the different tiers.

Habitat plays an important role in species composition, various assemblages and numbers of organisms found in aquatic environments. To make meaningful impact analyses, one must consider habitat data as a possible limiting factor. The habitat assessment score was 142 for station SFP-1 falling into the "Suboptimal" category of habitat.
